# PENNSYLVANIA'S FIRST EXODERMIC DECK: ACCELERATED DECK REPLACEMENT & REHABILITATION OF THE LIBERTY BRIDGE

## BRIDGE HISTORY

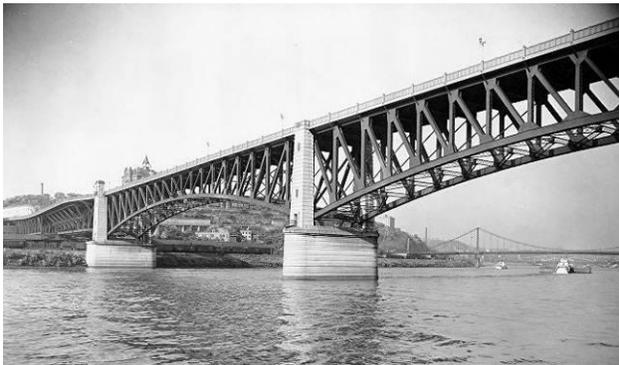
**Figure 1:** Historic Photograph of the Liberty Bridge

The Liberty Bridge is a 2,600 foot long deck truss bridge that crosses the Monongahela River in downtown Pittsburgh. The bridge has provided a vital link for commuters to the South Hills of Pittsburgh since it was constructed in 1928 (Fig. 1).

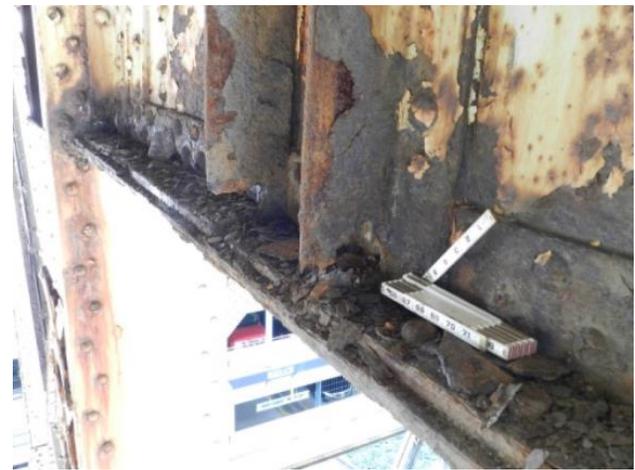
While the asphalt overlay on the existing grid deck was in "good condition", underlying deterioration was abundant, yet not apparent to the travelling public. Severe steel deterioration was occurring at most of the joint locations. The asphalt and grid deck was saturated along the gutter lines, with water leaking down onto the superstructure below during the driest of weather. (Fig. 2).

**Figure 2:** typical superstructure condition at leaking joint.

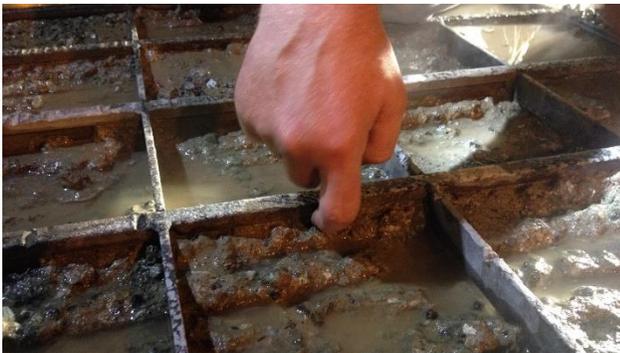
It was further decided to perform some actual test patches of the 3 overlay options, (AAA concrete, LMC, and Polyester Polymer Concrete). Other than testing the performance of each overlay on the bridge, other benefits were at hand. We could verify the condition of the deck under the asphalt, as well as test the feasibility of surface preparation for the new overlays.

**Figure 3:** existing grid deck condition following hydro-demolition

In the end, all three overlays failed to perform adequately, while the surface preparation would be extremely slow, expensive, and difficult. It was decided to replace the deck, late in the design process due to these valuable findings.

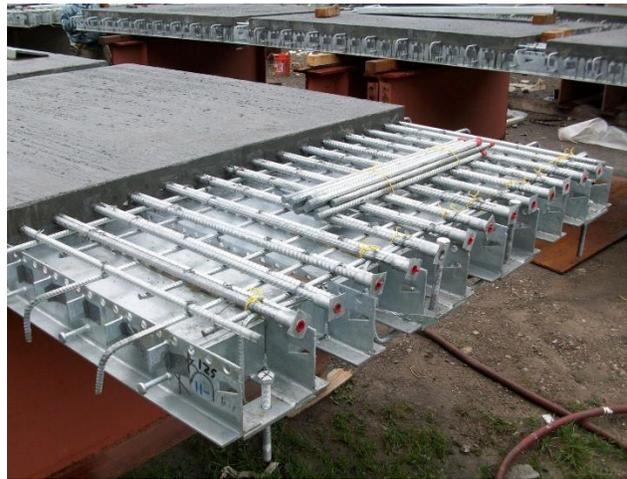
After investigation of several deck replacement options including lightweight cast-in-place and precast decks, traditional steel grid decks, and Exodermic grid decks, the Exodermic grid deck was selected. This type of deck is fabricated using WT sections which are made composting with approximately 4 inches of concrete (see Figure 4). The concrete includes one mat of reinforcement bars in each direction, acts in compression for positive bending, and provides a traditional wearing surface. The concrete can be cast in place after the panels are set like SIP forms, or it can be precast to accelerate construction.

**Figure 4:** Exodermic grid deck panel with reinforcement bars and precast panel zones

When the deck concrete is precast, as shown in Figures 4 and 5, blockouts are left around the steel panel edges, as well as over the locations of supporting beams. The prefabricated panels are placed on the bridge deck, and high early strength concrete can be used to fill these blockouts. This concrete makes the deck system composite with the supporting steel beams, and connects adjacent steel panels to form one composite deck structure. This permits installation of grid deck in short closure periods.

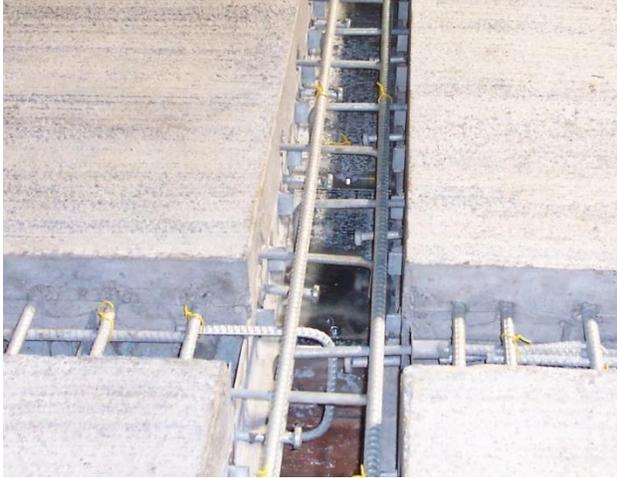
**Figure 5:** Exodermic grid deck panel with precast zones assembled on the bridge

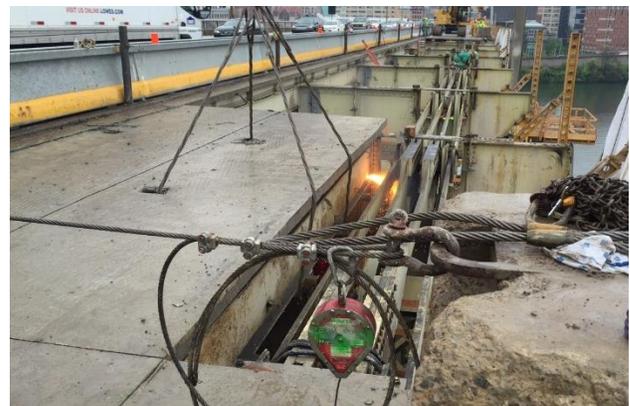
For most of the bridge, the deck could be replaced in quarter width passes, shifting three lanes of daytime traffic away from the work zone. Figure 6 shows a section of deck being removed. Following milling off all overlay material to save weight, panels of deck connected to individual stringers were sawcut. Lifting chains attached to an excavator supported the panels while the supporting stringer was cut at each end.

**Figure 6:** Preparation of the existing deck for removal: torch cutting stringer ends

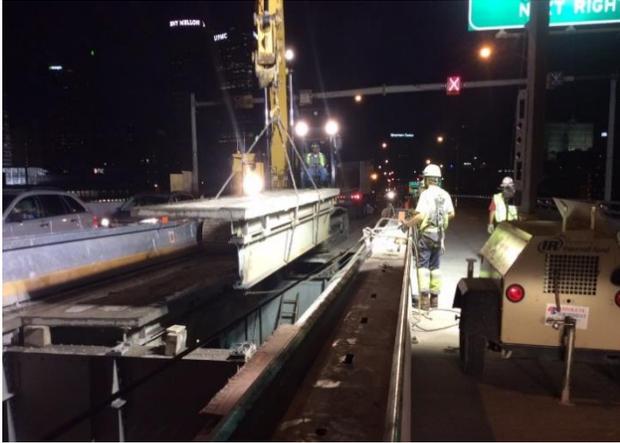
At night, the contractor was permitted to close an additional lane to aid in material removal, so much of the demolition work took place then.

**Figure 7:** Removal of existing stringer with section of deck during nighttime lane closure

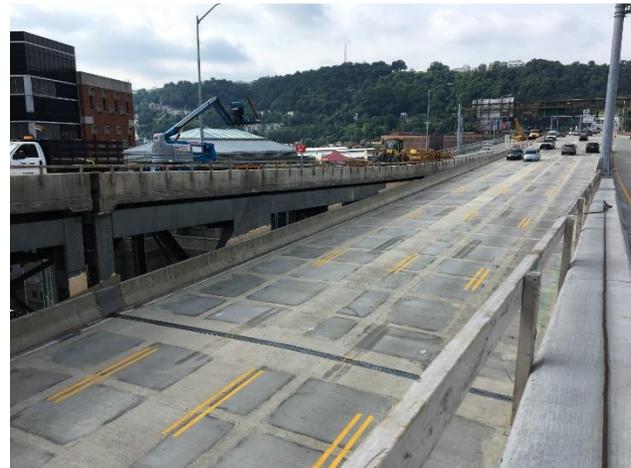
Figure 8 shows the northern section of bridge after the precast panels have been fully connected to each other and to the stringers using this high early strength concrete mix. This temporary surface will be prepared and overlaid with a Latex Modified Concrete (LMC) permanent wearing surface after all deck construction is complete. This overlay helps to protect the deck construction joints from moisture and provides a uniform appearance and ride quality.

**Figure 8:** Completed precast Exodermic grid deck section showing CIP concrete joints (lighter)
